**Flood Control Project Maintenance
Levee Inspections**

Fall 2013 Levee Maintenance Deficiency Summary Report

Brannan Andrus Levee Maintenance District

Levee Inspection Report By Mile - Fall 2013

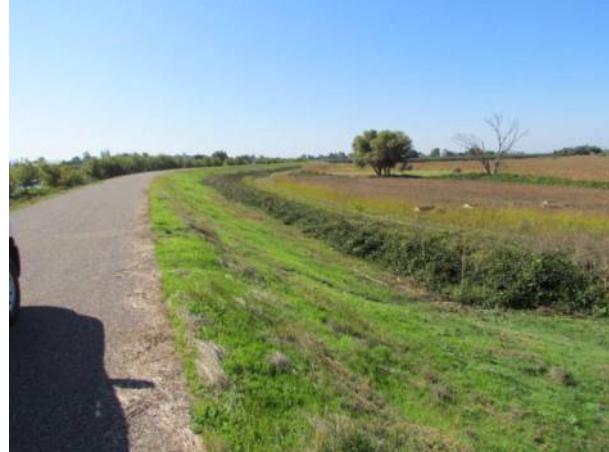
Levee Mile Report Line	4
Start Levee Mile	0.50
End Levee Mile	0.75
Location	Land Side
Category	Earthen Levee
Item	Vegetation
Looking southwest at wild roses or berry vines on landside toe.	
richard_f_20130930_509.jpg

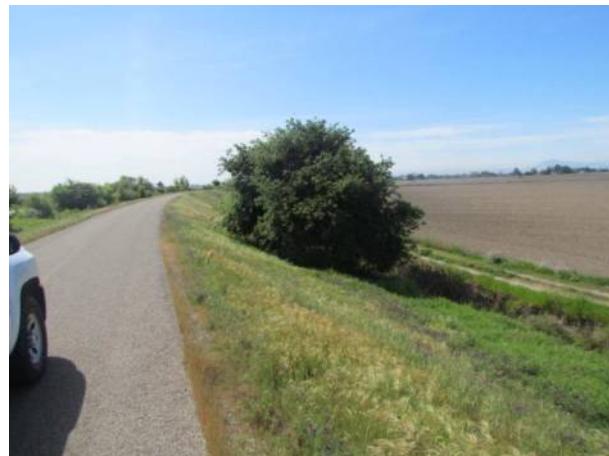
Levee Mile Report Line	5
Start Levee Mile	1.58
End Levee Mile	1.58
Location	Land Side
Category	Earthen Levee
Item	Trim / Thin Trees
Looking southwest at untrimmed tree on landward slope and toe.	
richard_f_20130930_524.JPG

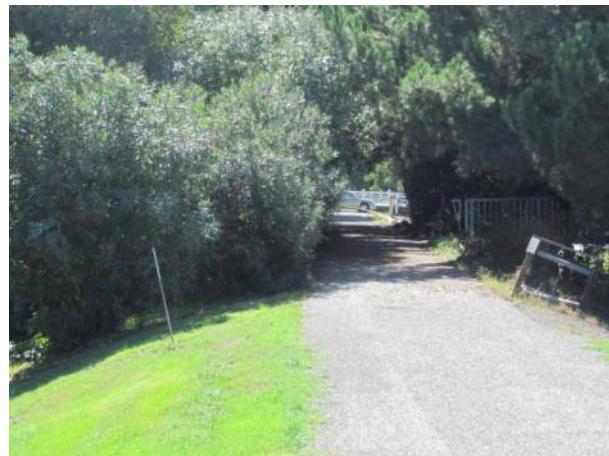
Levee Mile Report Line	8
Start Levee Mile	2.29
End Levee Mile	2.34
Location	Land Side
Category	Earthen Levee
Item	Vegetation
Looking south at dense landscape on waterside and landside of levee.	
richard_f_20130930_526.jpg

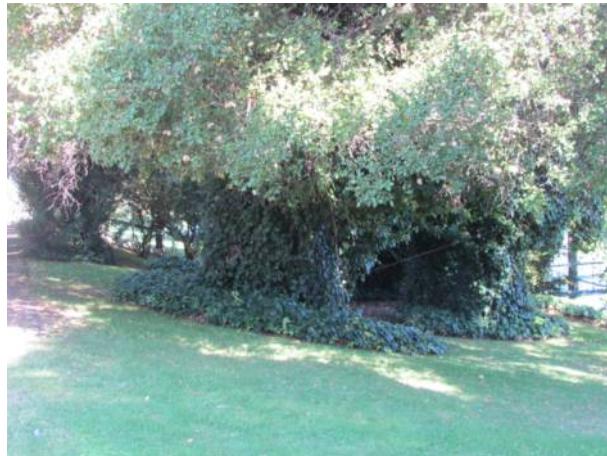
Levee Mile Report Line	8
Start Levee Mile	2.29
End Levee Mile	2.34
Location	Land Side
Category	Earthen Levee
Item	Vegetation
Looking north at dense vegetation on waterside slope.	
richard_f_20130930_528.jpg

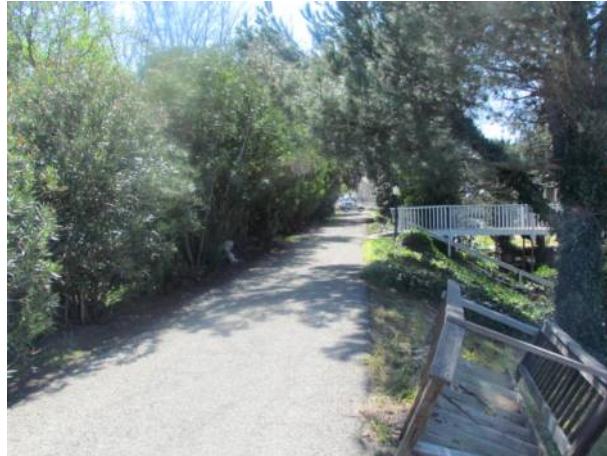
Levee Mile Report Line	8
Start Levee Mile	2.29
End Levee Mile	2.34
Location	Land Side
Category	Earthen Levee
Item	Vegetation
Looking south at dense oleander on waterside shoulder spring 2012	
richard_f_20130930_529.jpg

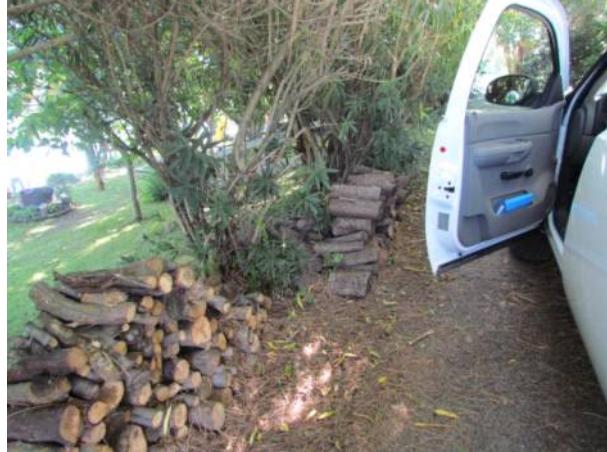
Levee Mile Report Line	9
Start Levee Mile	2.30
End Levee Mile	2.30
Location	Water Side
Category	Earthen Levee
Item	Encroachments
Looking east at firewood on waterside shoulder.	
richard_f_20130930_510.jpg

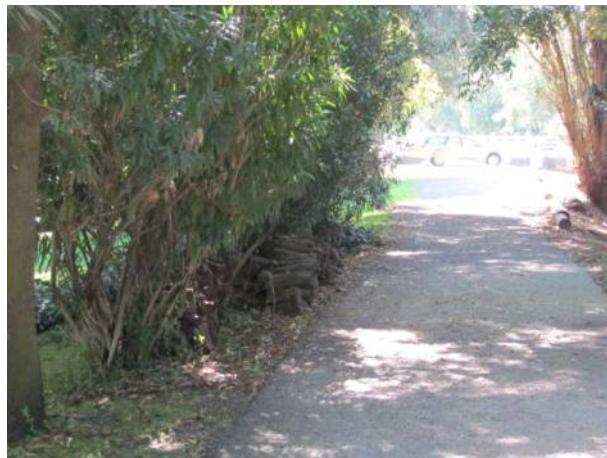
Levee Mile Report Line	9
Start Levee Mile	2.30
End Levee Mile	2.30
Location	Water Side
Category	Earthen Levee
Item	Encroachments
Looking south at firewood on waterside shoulder.	
richard_f_20130930_511.jpg

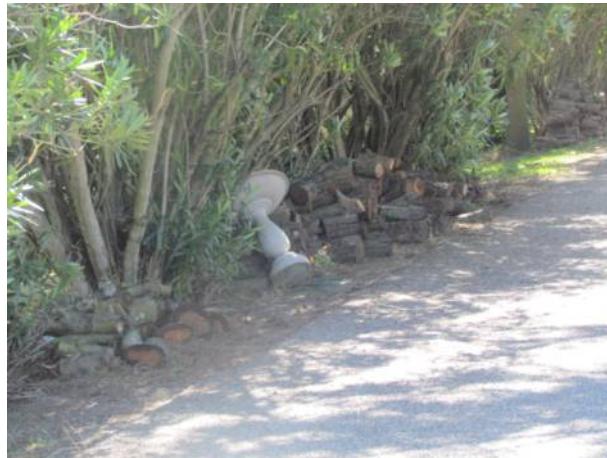
Levee Mile Report Line	9
Start Levee Mile	2.30
End Levee Mile	2.30
Location	Water Side
Category	Earthen Levee
Item	Encroachments
Looking southeast at firewood on waterside shoulder.	
richard_f_20130930_512.jpg

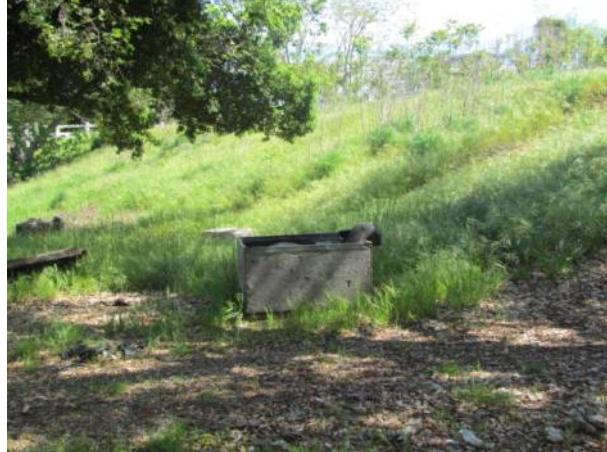
Levee Mile Report Line	11
Start Levee Mile	2.39
End Levee Mile	2.39
Location	Land Side
Category	Earthen Levee
Item	Encroachments
Looking northeast at garbage at landward toe.	
richard_f_20130930_514.JPG

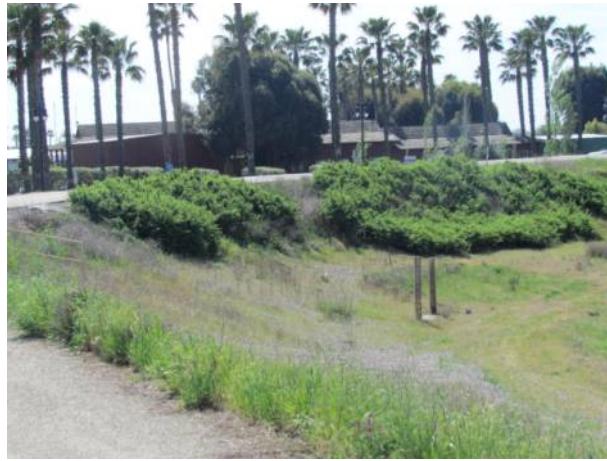
13	3.32 3.35	Earthen Levee	Vegetation	LS A/W Ma	V2 : Remove the wild growth other than native grasses from the levee slopes. Inspector Comments: Wild roses on landside slope.					38.152052 ° -121.591500 °	38.151683 ° -121.591662 ° Y

Levee Mile Report Line	13
Start Levee Mile	3.32
End Levee Mile	3.35
Location	Land Side
Category	Earthen Levee
Item	Vegetation
Looking south at wild roses on landward slope and toe.	
richard_f_20130930_525.JPG

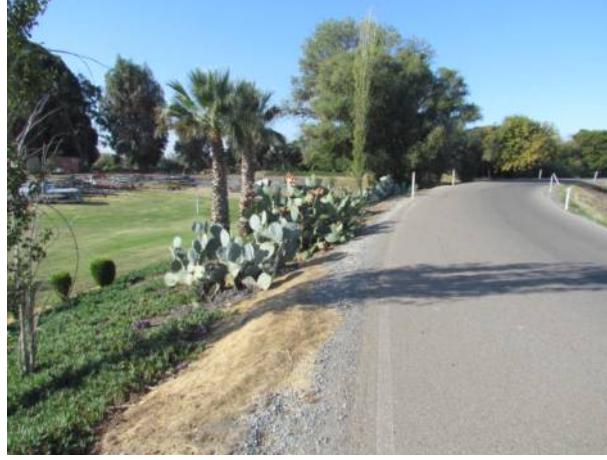
Levee Mile Report Line	14
Start Levee Mile	3.37
End Levee Mile	3.37
Location	Water Side
Category	Earthen Levee
Item	Vegetation
Looking south at cacti on waterward slope near Oxbow Harbor.	
richard_f_20131021_089.JPG

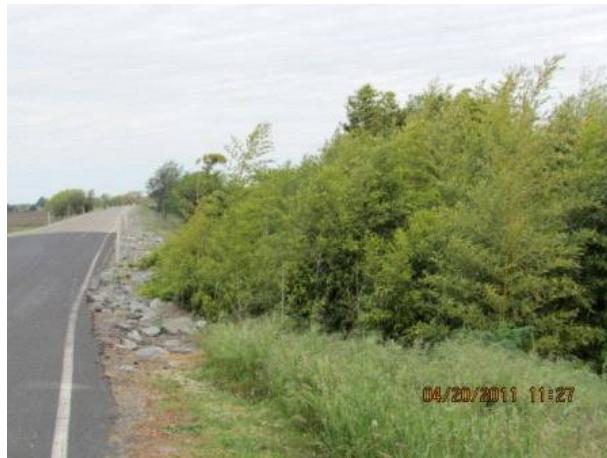
Levee Mile Report Line	18
Start Levee Mile	3.93
End Levee Mile	3.93
Location	Water Side
Category	Earthen Levee
Item	Vegetation
Looking west at dense vegetation on waterside slope.	
richard_f_20130930_515.jpg

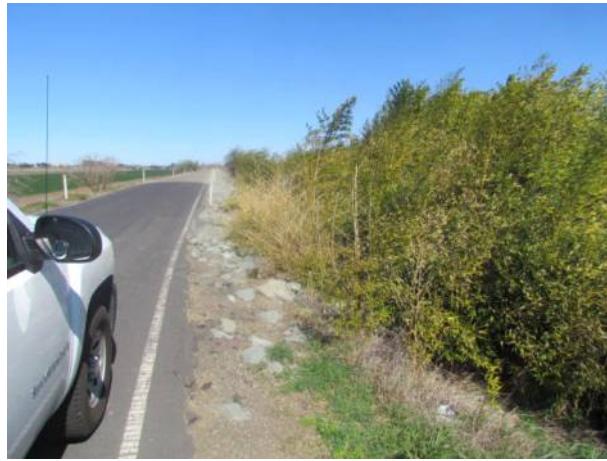
Levee Mile Report Line	18
Start Levee Mile	3.93
End Levee Mile	3.93
Location	Water Side
Category	Earthen Levee
Item	Vegetation
Looking west at dense vegetation on waterside slope spring 2012.	
richard_f_20130930_516.jpg

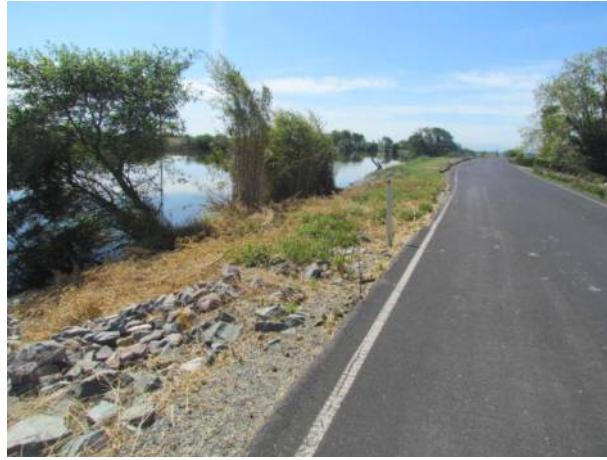
Levee Mile Report Line	18
Start Levee Mile	3.93
End Levee Mile	3.93
Location	Water Side
Category	Earthen Levee
Item	Vegetation
Looking south at dead willows on waterward slope. (Spring 2013)	
richard_f_20130930_517.JPG

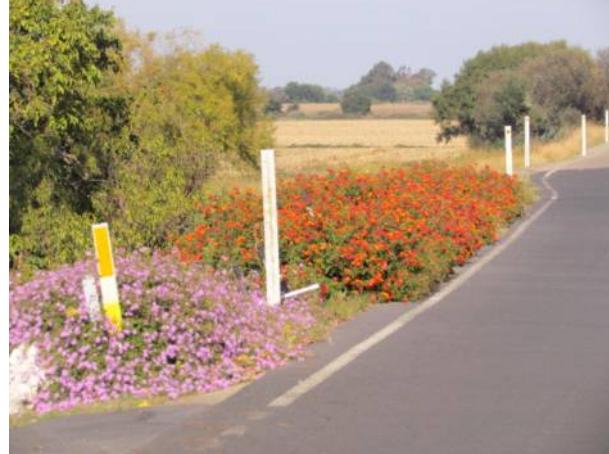
Levee Mile Report Line	19
Start Levee Mile	3.93
End Levee Mile	3.97
Location	Land Side
Category	Earthen Levee
Item	Vegetation
Looking northeast at landscaping on landside slope.	
richard_f_20130930_518.jpg

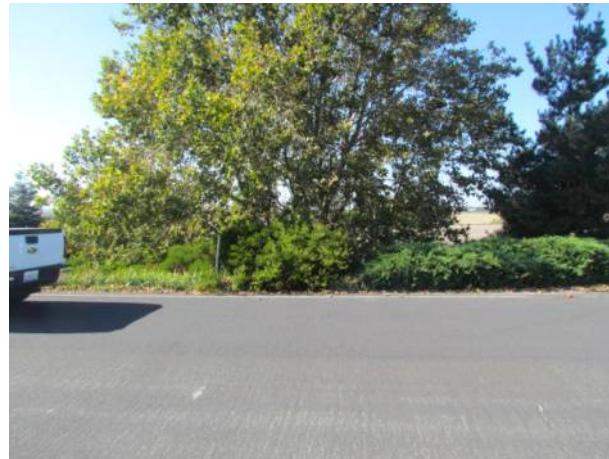
Levee Mile Report Line	19
Start Levee Mile	3.93
End Levee Mile	3.97
Location	Land Side
Category	Earthen Levee
Item	Vegetation
Looking west at dense landscaping on landside slope.	
richard_f_20130930_519.jpg

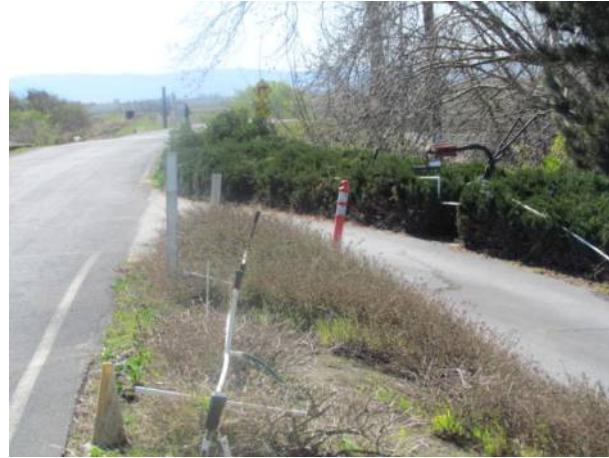
Levee Mile Report Line	19
Start Levee Mile	3.93
End Levee Mile	3.97
Location	Land Side
Category	Earthen Levee
Item	Vegetation
Looking south at brushes on landside shoulder and slope.	
richard_f_20130930_520.jpg

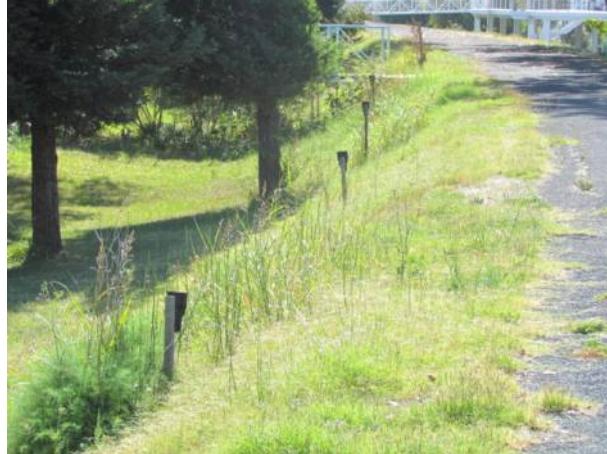
Levee Mile Report Line	21
Start Levee Mile	4.22
End Levee Mile	4.28
Location	Water Side
Category	Earthen Levee
Item	Encroachments
Looking south at a sprinkler system on waterward slope.	
richard_f_20131021_090.JPG

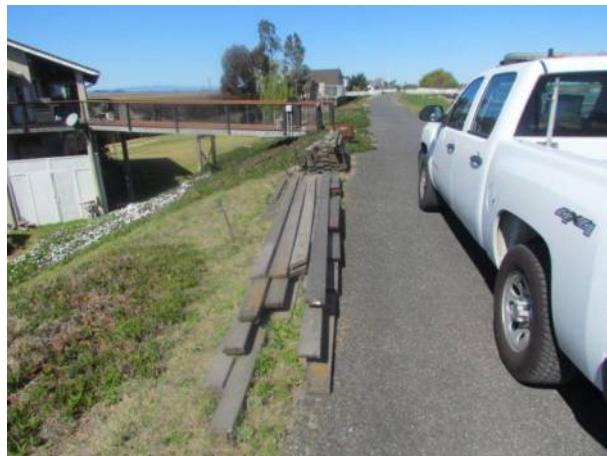
Levee Mile Report Line	24
Start Levee Mile	4.78
End Levee Mile	4.78
Location	Land Side
Category	Earthen Levee
Item	Encroachments
Looking northwest at wooden boards on landside shoulder.	
richard_f_20130930_523.jpg

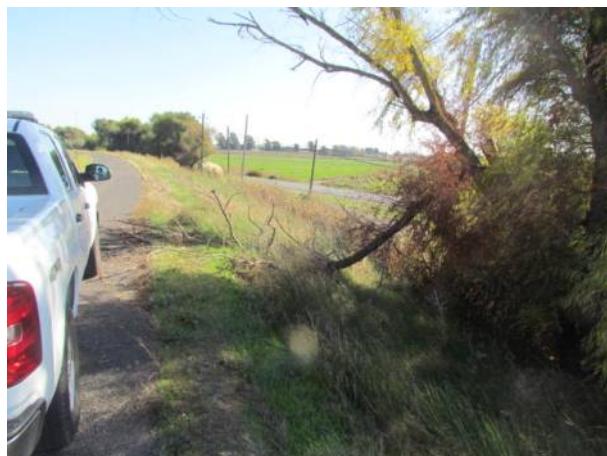
Levee Mile Report Line	30
Start Levee Mile	5.42
End Levee Mile	5.42
Location	Land Side
Category	Earthen Levee
Item	Encroachments
Looking southwest at a downed tree limb on landside slope.	
richard_f_20130930_513.jpg

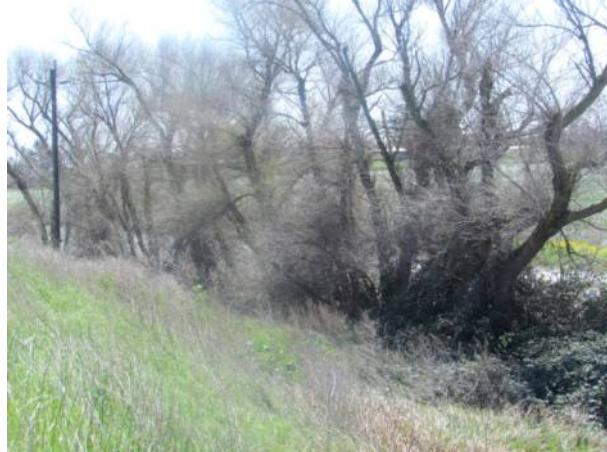
Levee Mile Report Line	31
Start Levee Mile	5.46
End Levee Mile	5.57
Location	Land Side
Category	Earthen Levee
Item	Vegetation
Looking south at trees, berry vines, and wild rose on landside toe.	
richard_f_20130930_522.jpg

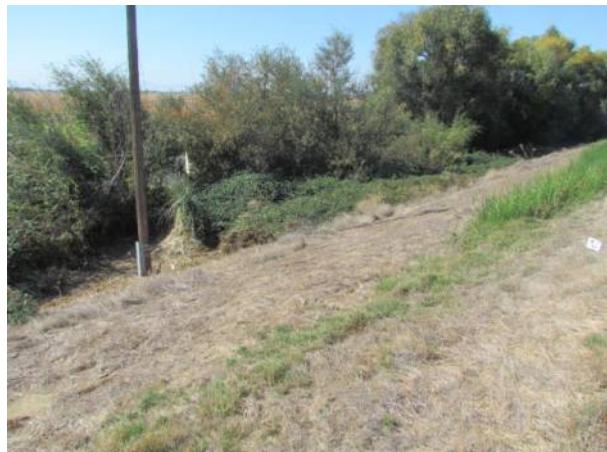
Levee Mile Report Line	31
Start Levee Mile	5.46
End Levee Mile	5.57
Location	Land Side
Category	Earthen Levee
Item	Vegetation
Looking south at dense berry vines and trees on the landward slope and toe.	
richard_f_20131021_091.JPG

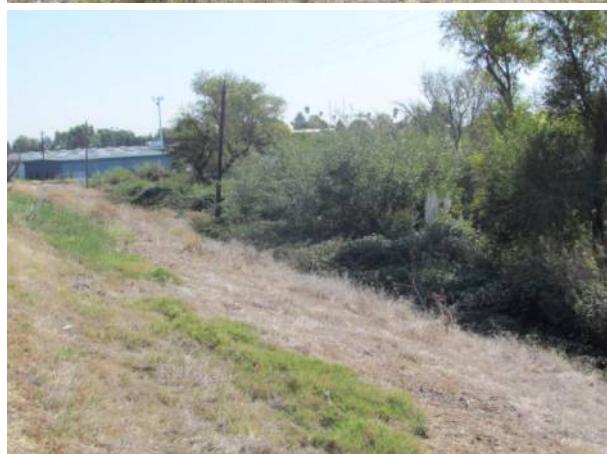
Levee Mile Report Line	31
Start Levee Mile	5.46
End Levee Mile	5.57
Location	Land Side
Category	Earthen Levee
Item	Vegetation
Looking east at dense vegetation on landward toe.	
richard_f_20131021_092.JPG

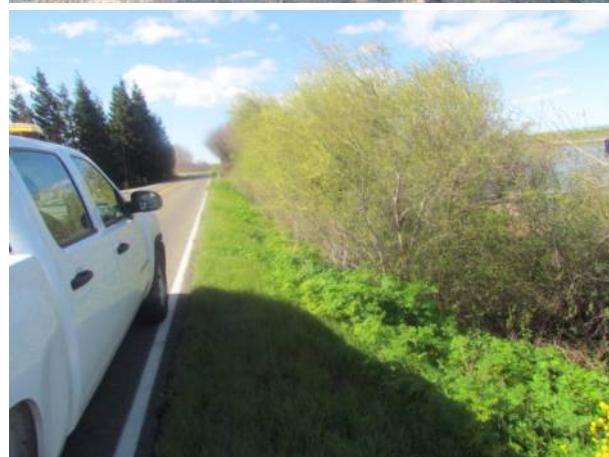
Levee Mile Report Line	5
Start Levee Mile	0.78
End Levee Mile	0.83
Location	Water Side
Category	Earthen Levee
Item	Trim / Thin Trees
Looking south at dense vegetation on waterside slope.	
richard_f_20130930_530.jpg

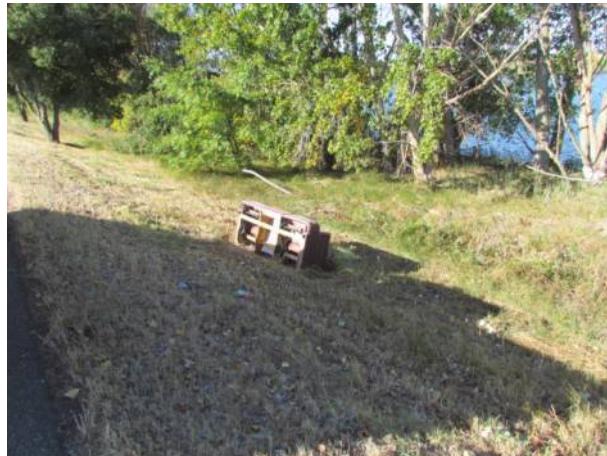
Levee Mile Report Line	7
Start Levee Mile	1.16
End Levee Mile	1.16
Location	Water Side
Category	Earthen Levee
Item	Encroachments
Looking southwest at garbage on waterward slope and toe.	
richard_f_20131021_078.JPG

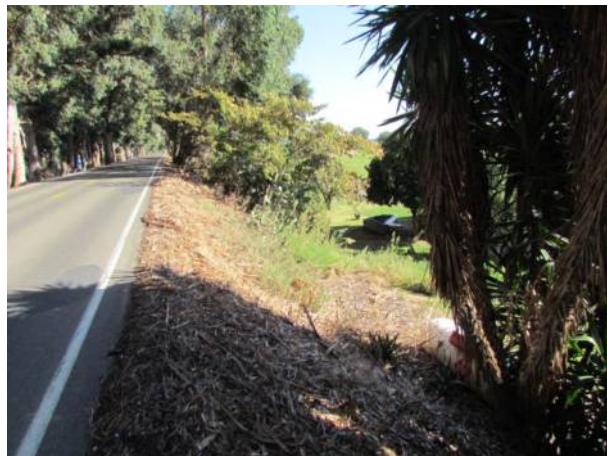
Levee Mile Report Line	12
Start Levee Mile	1.80
End Levee Mile	1.82
Location	Land Side
Category	Earthen Levee
Item	Vegetation
Looking north at dense vegetation on landward slope and toe.	
richard_f_20131021_080.JPG

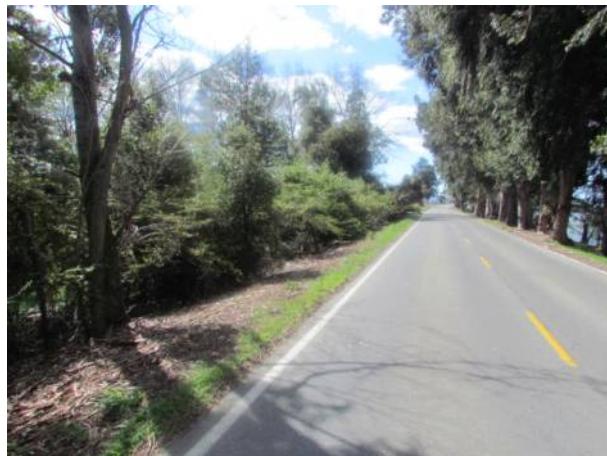
Levee Mile Report Line	18
Start Levee Mile	1.91
End Levee Mile	1.95
Location	Land Side
Category	Earthen Levee
Item	Vegetation
Looking south at dense landscaping on landside slope and toe.	
richard_f_20130930_539.jpg

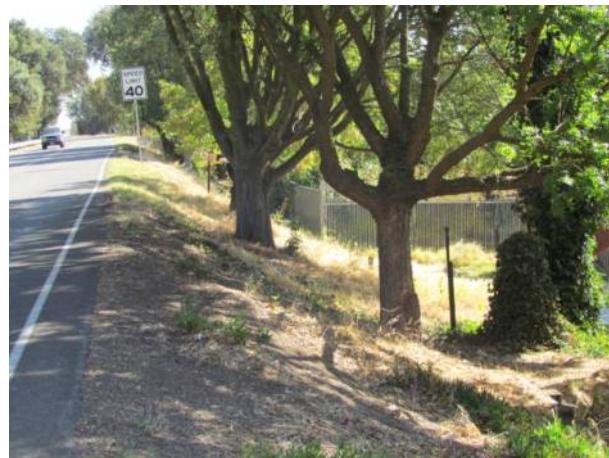
Levee Mile Report Line	23
Start Levee Mile	2.93
End Levee Mile	3.13
Location	Land Side
Category	Earthen Levee
Item	Encroachments
Looking north at urban encroachments on landward slope and toe.	
richard_f_20131021_085.JPG

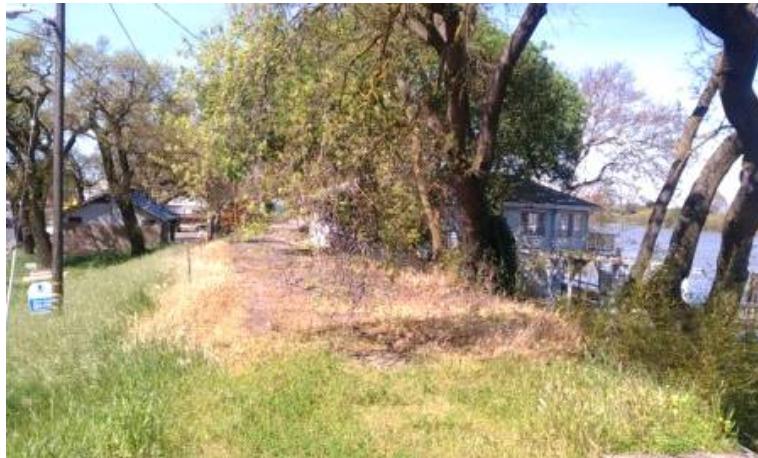
Levee Mile Report Line	24
Start Levee Mile	3.17
End Levee Mile	3.17
Location	Water Side
Category	Earthen Levee
Item	Trim / Thin Trees
Looking south at overhanging tree on waterside shoulder.	
richard_f_20130930_531.jpg

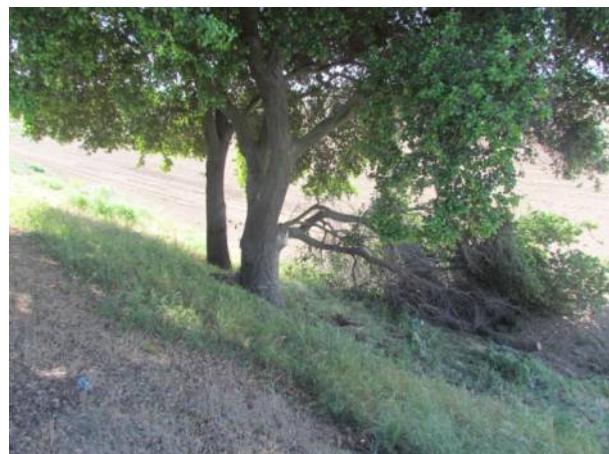
Levee Mile Report Line	34
Start Levee Mile	4.59
End Levee Mile	4.59
Location	Land Side
Category	Earthen Levee
Item	Encroachments
Looking northeast at broken tree limb on landward slope and toe.	
richard_f_20130930_577.JPG

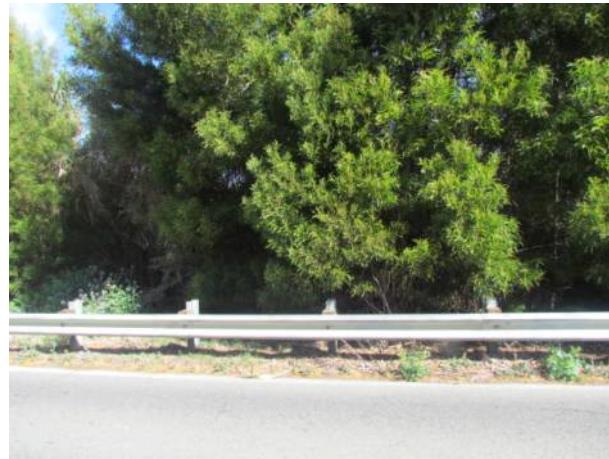
Levee Mile Report Line	35
Start Levee Mile	5.19
End Levee Mile	5.43
Location	Water Side
Category	Earthen Levee
Item	Trim / Thin Trees
Looking west at dense trees on waterward shoulder and slope.	
richard_f_20130930_535.JPG

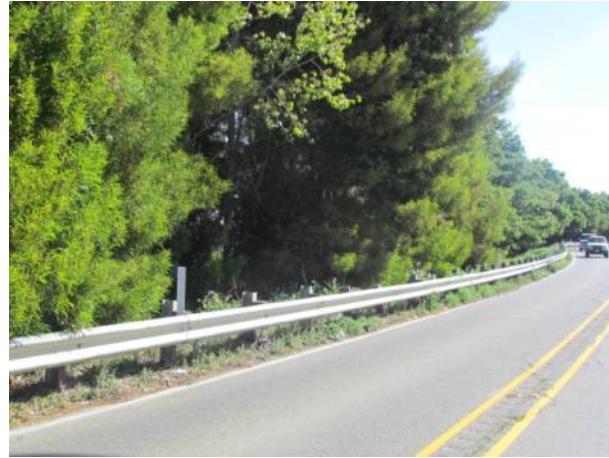
Levee Mile Report Line	35
Start Levee Mile	5.19
End Levee Mile	5.43
Location	Water Side
Category	Earthen Levee
Item	Trim / Thin Trees
Looking northwest at dense trees on waterward shoulder and slope.	
richard_f_20130930_536.JPG

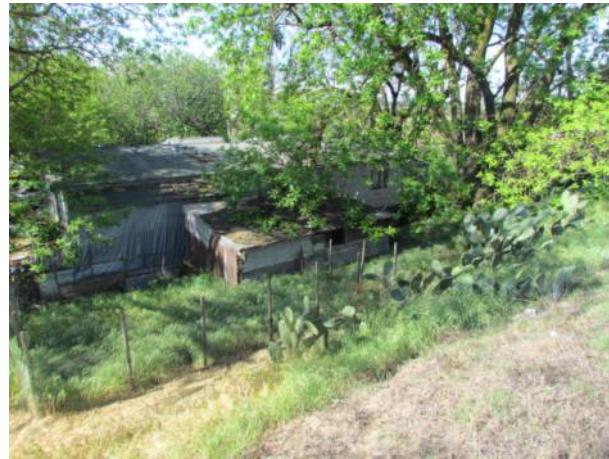
Levee Mile Report Line	41
Start Levee Mile	5.70
End Levee Mile	5.70
Location	Land Side
Category	Earthen Levee
Item	Encroachments
Looking east tool shed and animal corral on landward slope and toe.	
richard_f_20130930_576.JPG

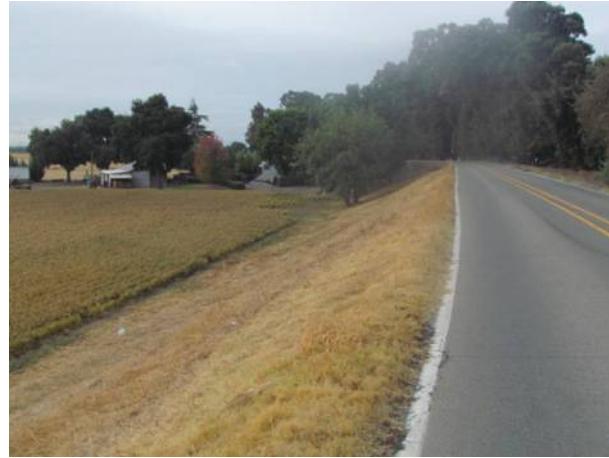
Levee Mile Report Line	43
Start Levee Mile	5.82
End Levee Mile	6.15
Location	Land Side
Category	Earthen Levee
Item	Vegetation
Looking southeast at compliant vegetation on landside slope.	
richard_f_20130930_540.JPG

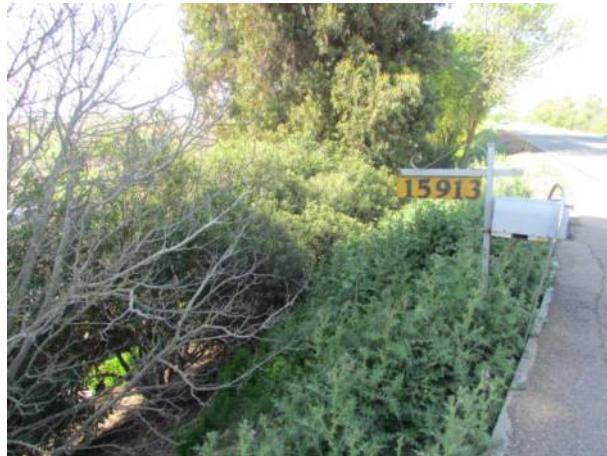
Levee Mile Report Line	44
Start Levee Mile	6.29
End Levee Mile	6.29
Location	Land Side
Category	Earthen Levee
Item	Vegetation
Looking south at dense landscaping on landward slope.	
richard_f_20130930_575.JPG

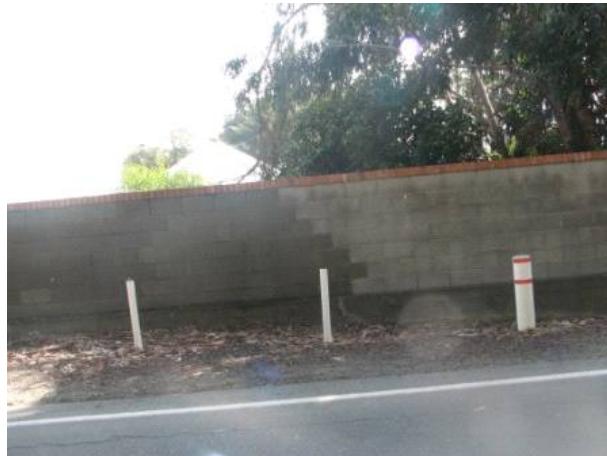
Levee Mile Report Line	46
Start Levee Mile	6.82
End Levee Mile	6.82
Location	Land Side
Category	Earthen Levee
Item	Encroachments
Brick wall on landside shoulder at LM 6.82.	
richard_f_20130930_570.jpg

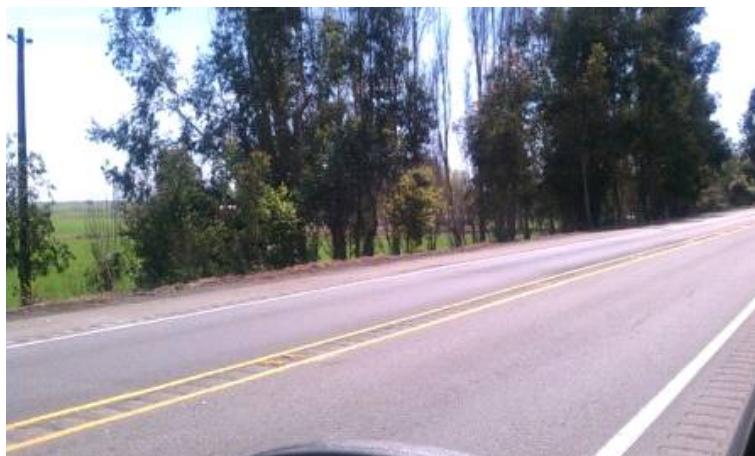
Levee Mile Report Line	51
Start Levee Mile	8.35
End Levee Mile	8.71
Location	Land Side
Category	Earthen Levee
Item	Trim / Thin Trees
Looking southeast at trees on landside shoulder and slope.	
richard_f_20130930_571.jpg

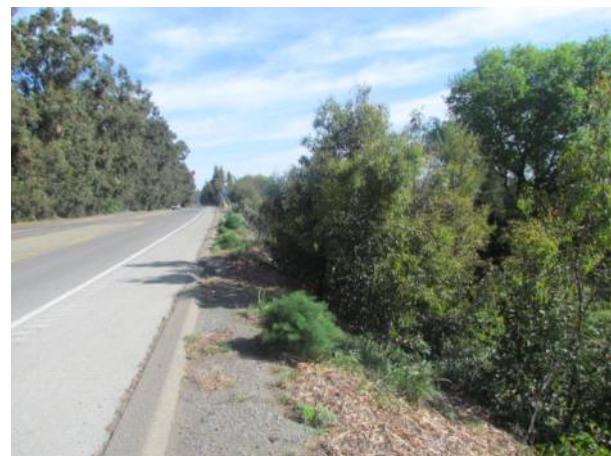
Levee Mile Report Line	54
Start Levee Mile	8.68
End Levee Mile	8.89
Location	Land Side
Category	Earthen Levee
Item	Trim / Thin Trees
Looking north at dense trees on landward slope and toe.	
richard_f_20130930_572.JPG
